Inspection Report

Property Address:
123 Rainbow Blvd
Las Vegas NV 89108

TK Home Inspections

Date: 7/13/2012	Time: 11:00 AM	Report ID: 13121
Property: 123 Rainbow Blvd Las Vegas NV 89108	Customer: Mr. and Mrs. John Doe	Real Estate Professional:

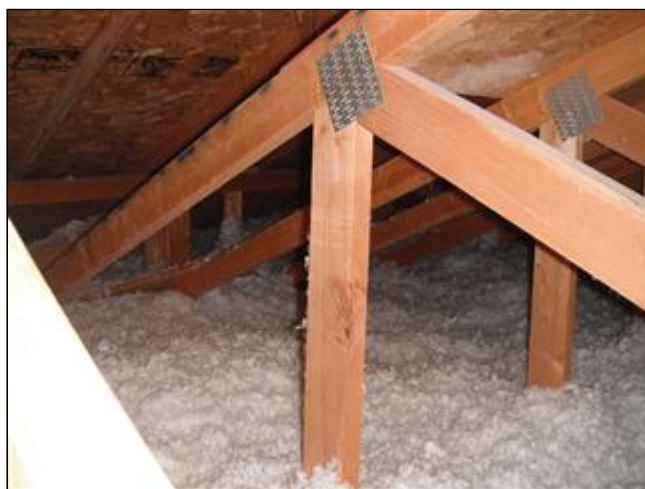
1.4 Picture 1

Looks good, spread threw out attic.

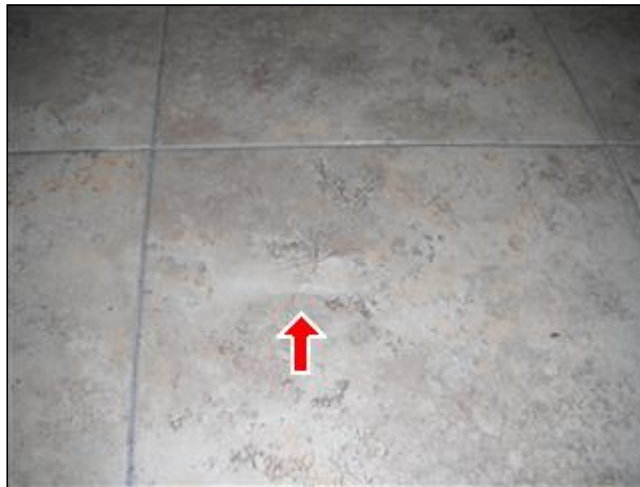
2.2 Picture 1

Small indent in kitchen floor.

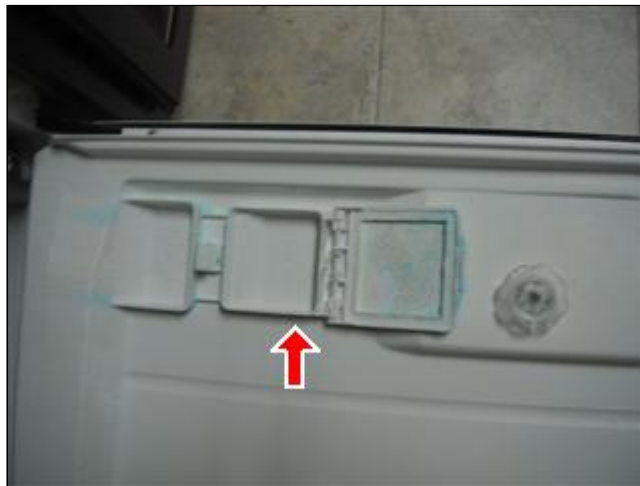
2.9 Picture 1

Runs good, drain backs up in sink when draining. Latch inside dishwasher for detergent was not closing properly.

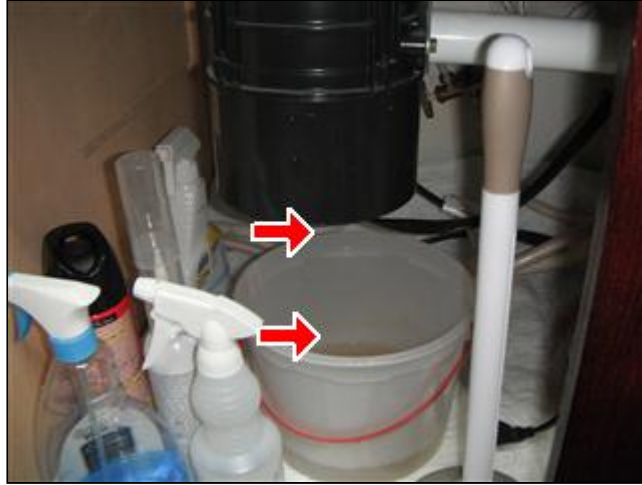
2.12 Picture 1

The food disposer would not operate or non functional, and is backing up water from dishwasher when in use. It also drips water when water is running. I recommend repair by a licensed plumber as needed.

The food disposer would not operate or non functional, and is backing up water from dishwasher when in use. It also drips water when water is running. I recommend repair by a licensed plumber as needed.

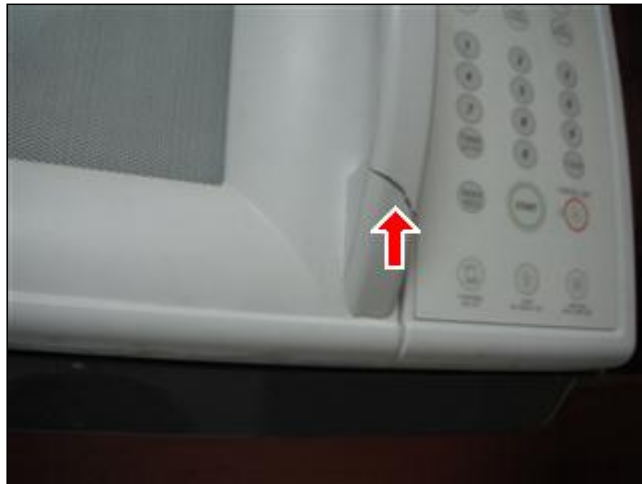
2.13 Picture 1

Works good. Has crack in handle. Missing shelf, found one on fridge, not sure if it's the right one for that microwave.

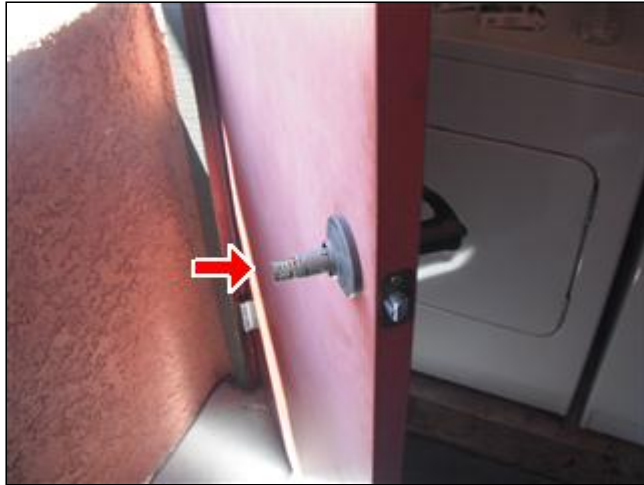
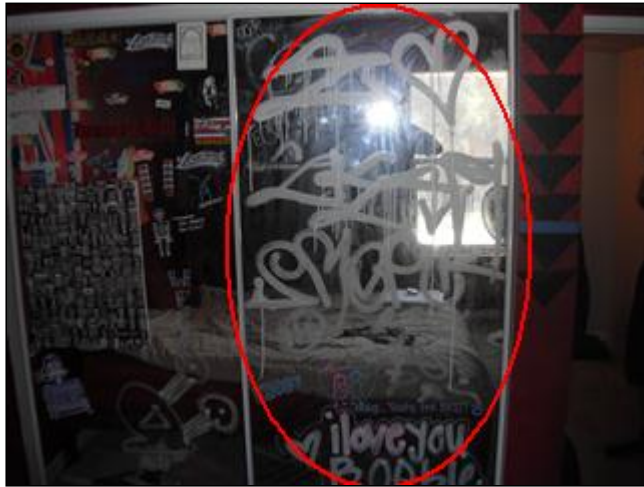
3.4 Picture 1

Laundry door has missing handle. Bedroom sliding glass door has some sort of writing that looks to be in paint. Sliding glass door to balcony is hard to lock and screen door does not lock.

Laundry door has missing handle. Bedroom sliding glass door has some sort of writing that looks to be in paint. Sliding glass door to balcony is hard to lock and screen door does not lock.

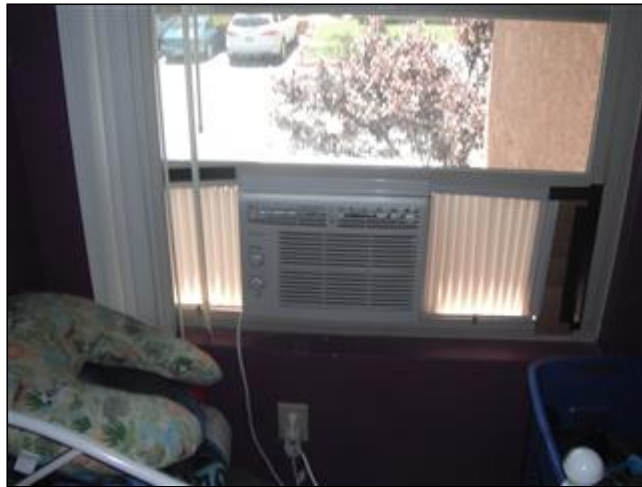
3.5 Picture 1

Unable to check bedroom window because window ac unit. Missing screen, found screen in closet, not sure if fits that window.

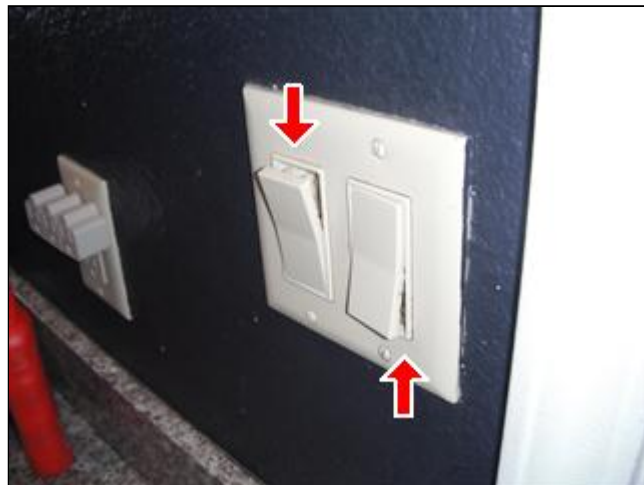
4.5.A Picture 1

Bath switches need to be replaced, I recommend a licensed electrician to replace switch.

Bath switches need to be replaced, I recommend a licensed electrician to replace switch.

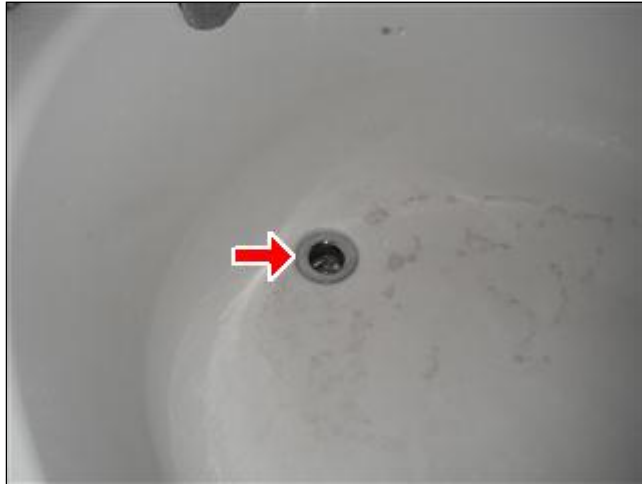
4.3.B Picture 1

Master bath is missing drain plug.

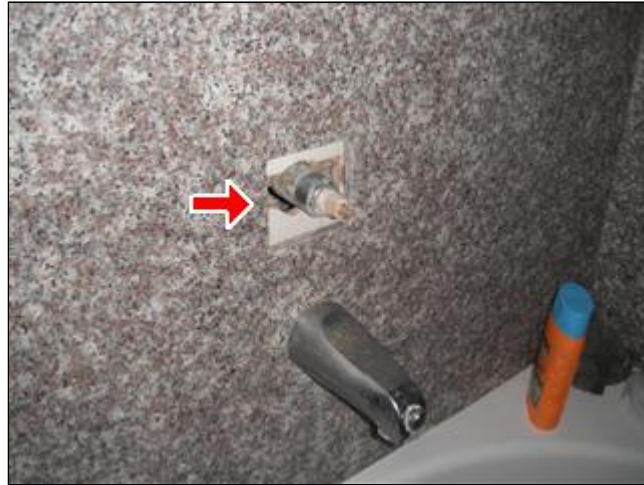
4.4.B Picture 1

The control lever is missing at the master bath. . A qualified licensed plumber should repair or correct as needed.

The control lever is missing at the master bath. . A qualified licensed plumber should repair or correct as needed.

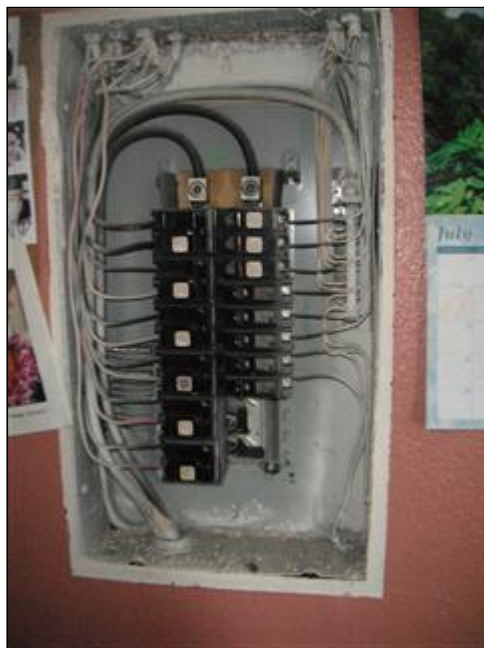
6.1 Picture 1

Looks good.

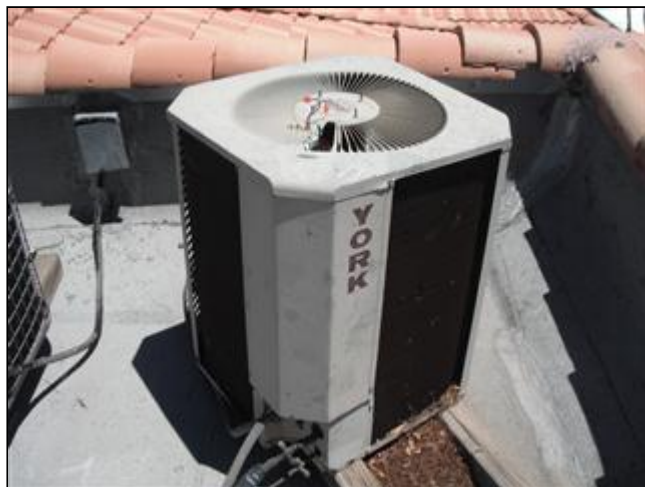
7.4 Picture 1

Same equipment as when condo was built. Difference between return and vents between 10-15 degrees, normal degrees differential is 18-20 degrees. There was no filter in the return, owner already had ac running, A-coil may need cleaning. I recommend a licensed HVAC company to check entire system.

Same equipment as when condo was built. Difference between return and vents between 10-15 degrees, normal degrees differential is 18-20 degrees. There was no filter in the return, owner already had ac running, A-coil may need cleaning. I recommend a licensed HVAC company to check entire system.
